BP CATS Gas Pipeline Repair

FoundOcean repairs one of the UK's major gas supply pipelines following damage from a vessel's anchor

FoundOcean helps reinstate UK gas supplies following vessel damage to BP CATS in 2007

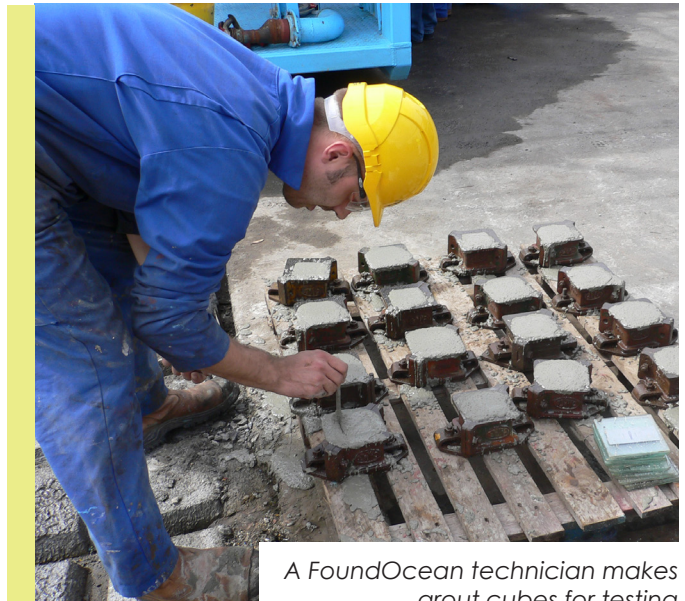
A FoundOcean technician makes grout cubes for testing

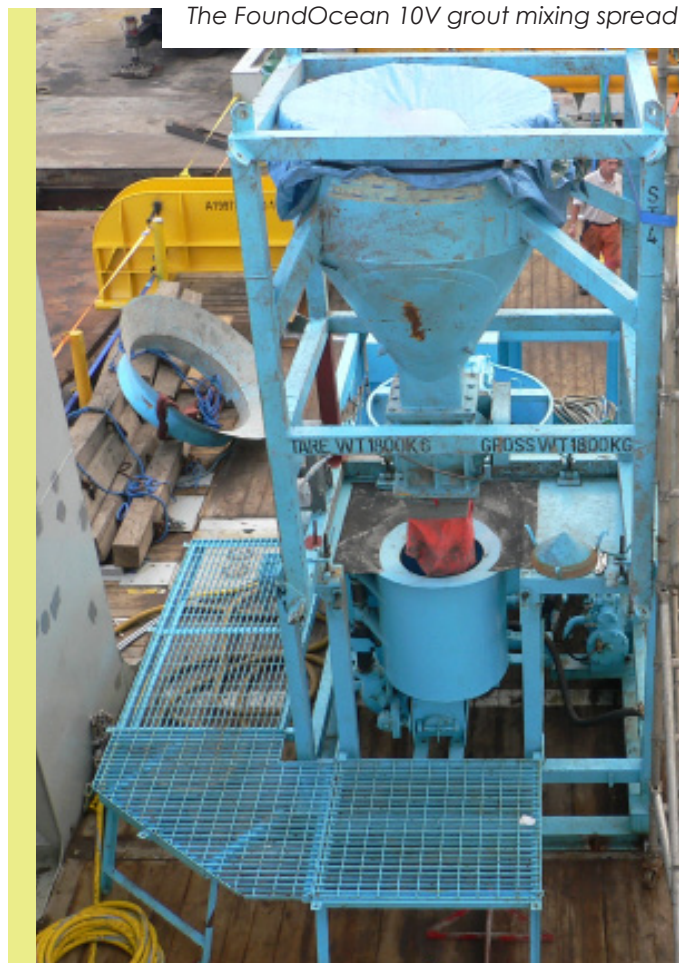
The FoundOcean 10V grout mixing spread
