# Deep Water Pipeline Repair

## Deploying a grouted clamp and fabric formwork to repair a damaged pipeline

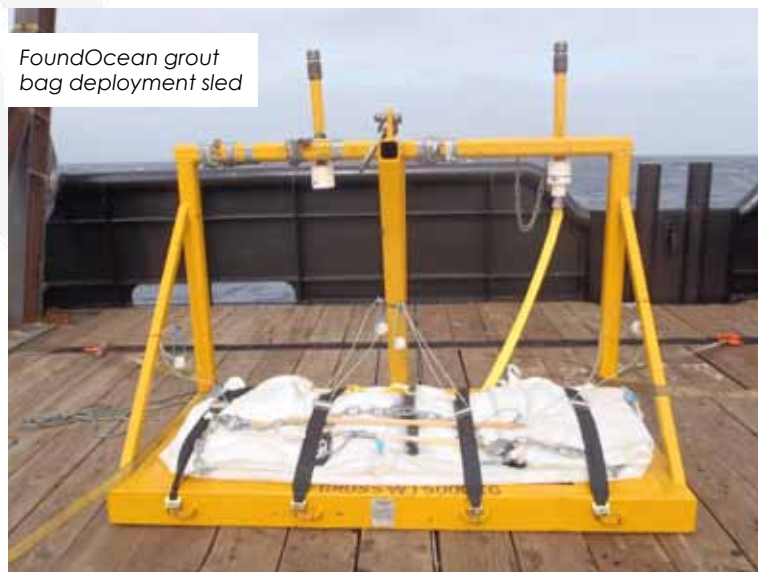
FoundOcean grout bag deployment sled

Because the pipeline was now carrying the added load of the grout and clamp, a fabric formwork was used to provide additional support. A deployment frame designed for transporting, installing and filling grout bags was used to place the grout bag under the pipeline. The ROV then connected the grout hose to the connector on the frame and grout was pumped into the bag.
