# Baobab Gas Pipeline Supports

FoundOcean breaks the depth record by going to 1,224 m to stabilise the Baobab pipeline, Ivory Coast

# Record breaking water depths to stabilise the Baobab pipeline on The Ivory Coast

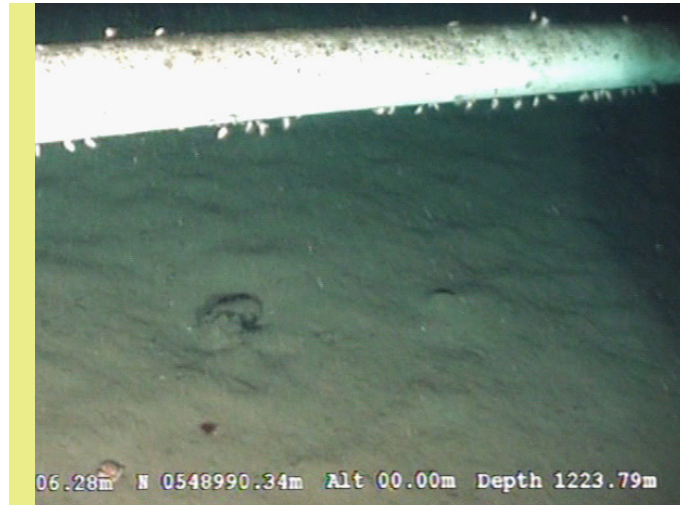
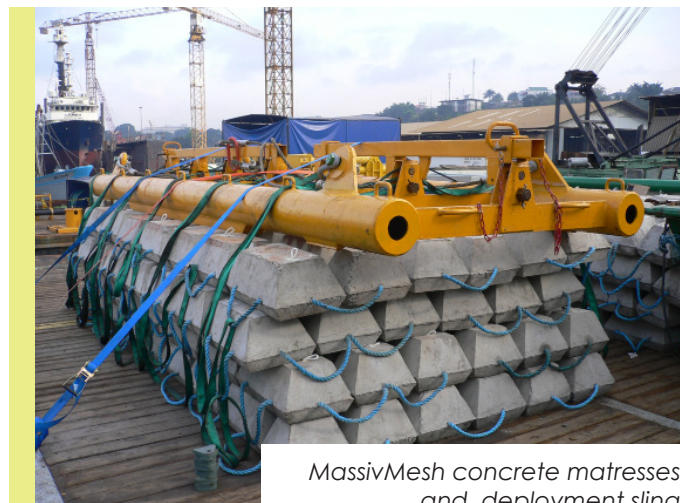
MassivMesh concrete mattresses and deployment sling

The grout bag shifted under the weight of grout so the ROV attempted to reposition the formwork. The first attempt failed and the hose was flushed to stop any grout from curing in the grout line. It was decided to grout the same location this time with a concrete mattress positioned on the upper side of the slope for stability.

The ROV secured the anchoring hooks to the concrete mattress and positioned the grout bag further under the pipeline. Grouting commenced and the grout line was purged with water once the required grout has been pumped until good returns are seen exiting the grout bag. The remaining formworks were also deployed with concrete mattresses for stability.

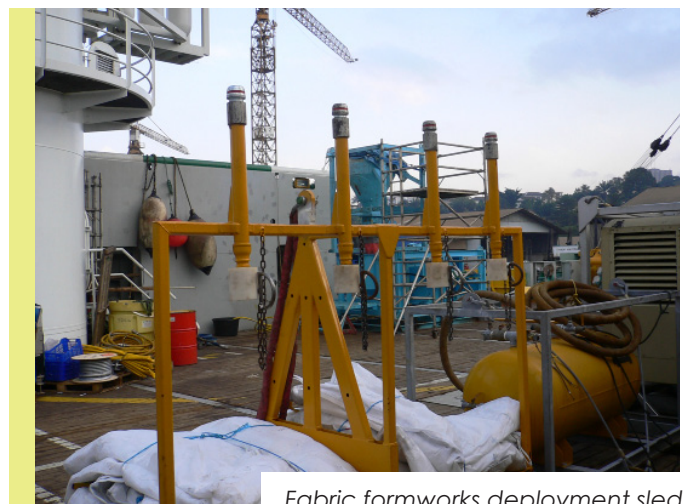
Fabric formworks deployment sled

Once we arrived at the site the clump weight was lifted overboard by crane and hose deployment started. Grout bags were then loaded onto the skid and secured, monkey fists were attached where required and hoses were fastened to the side of the skid so to be clear of the ROV.

The skid was deployed to the sea bed. The grout bag was then released and positioned under the 6" pipeline. The ROV connected the female connector. Poor visibility led to the ROV knocking the skid over with the tether so we flushed the hose with water to inspect for any damage.
