# BP CATS Gas Pipeline Repair

FoundOcean repairs one of the UK's major gas supply pipelines following damage from a vessel's anchor

# FoundOcean helps reinstate UK gas supplies following vessel damage to BP CATS in 2007

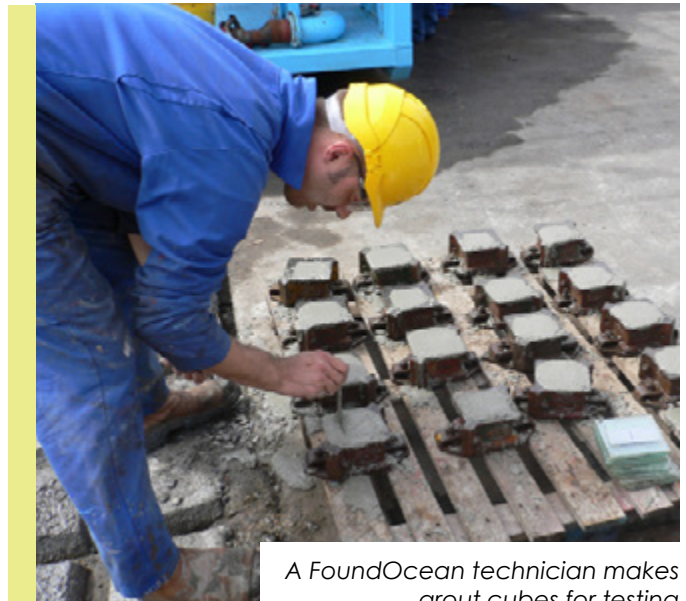
*A FoundOcean technician makes grout cubes for testing*

During mixing, the slurry density was monitored at intervals using a pressurised slurry density balance. Two samples were taken during the grouting of the sleeve, one at the start of grouting and one at the end of grouting, once satisfactory returns had been observed. For each sample the slurry density was measured and recorded and 19 75mm grout cubes were manufactured. Each cube was marked to identify the project, time and date of casting and the specific gravity. The samples were cured underwater at  $10^{\circ}\text{C} \pm 1^{\circ}\text{C}$  until removed for testing.

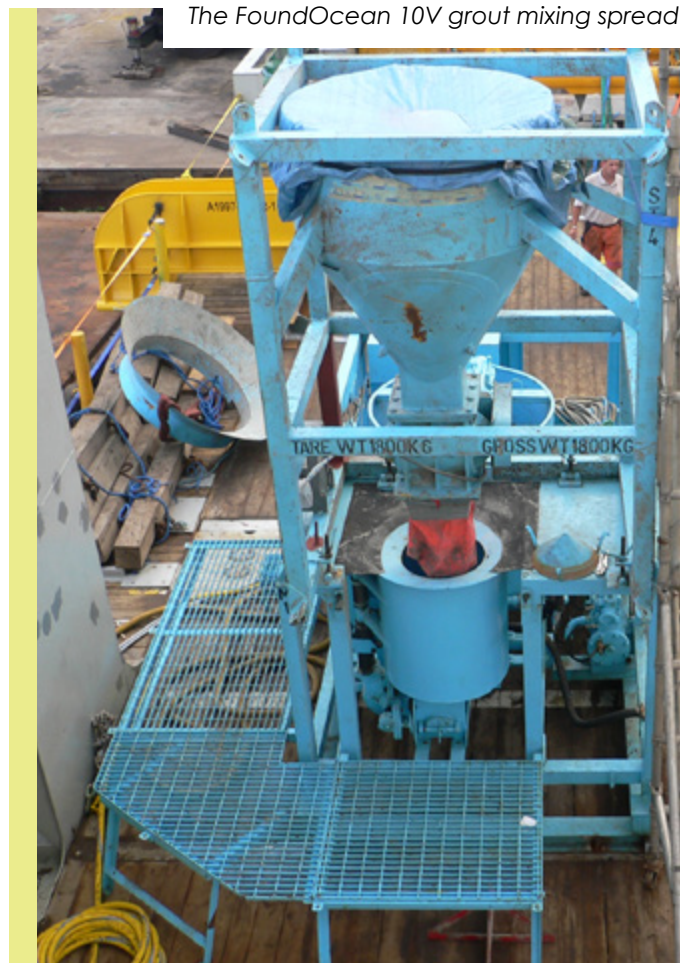
*The FoundOcean 10V grout mixing spread*

Cement was stored in a bulk pressurised silo and delivered to a surge tank above the mixer. Water was delivered to the mixer from the vessel firemain pipework and measured into the mixing tank through a mechanical flowmeter. Cement was added to the water through a rotary valve which was controlled by a timer. The grout was mixed by means of a recirculating pump. The grout was then transferred to a 2m<sup>3</sup> capacity holding tank from where it was drawn off by the pump and delivered to the repair sleeve via a flexible hose. The grout was mixed and pumped at a rate of between 5.0 - 8.0m<sup>3</sup> per hour.
