# Jacket Stabilisation

## Using bespoke grout bags to restabilise a platform to extend its life expectancy

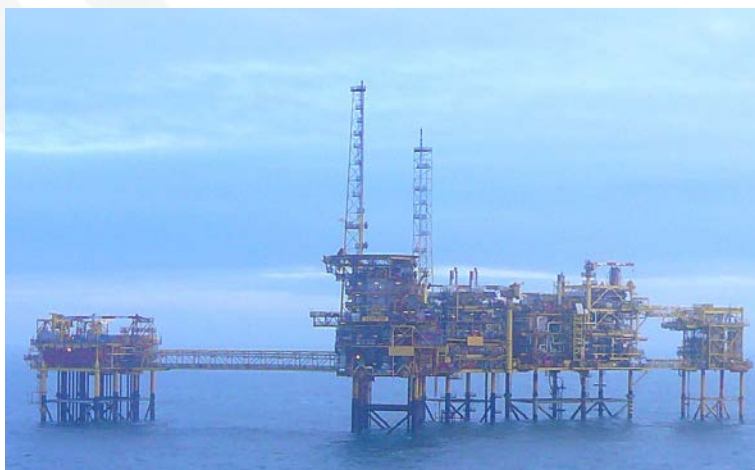
Scour had occurred at the bottom of the jacket legs and as such, the mudmats were no longer sitting on the seabed and this was putting stress on the welded connection. The solution was a three stage fix to strengthen the leg-to-pile connections and reinstate the mudmat supports.

Each bespoke donut-shaped grout bag was placed under and around the mudmats. This formed a seal for the next phase which involved pumping grout into the void under each mudmat. As well as giving additional support to the jacket, grouting the void formed a seal at the bottom of the pile annuli as they had not been designed with grouted connections in mind. The final stage of the project was to fill the annuli with grout, eliminating any movement in the jacket.

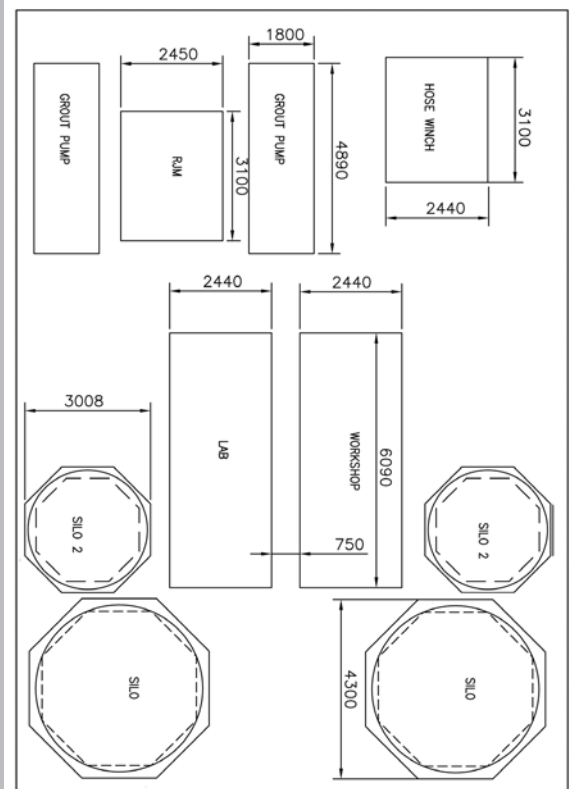
### TYPICAL RJM DECK PLAN

Industry	Oil & Gas
Region	Southern North Sea
Services	Jacket Stabilisation
Project year	2011
Operator	<i>undisclosed</i>
Contractor	<i>undisclosed</i>
Water depth	22 m
Cement type	OPC CEM I 52.5
Total cement	69 t
Mixer type	Recirculating Jet Mixer
Grout specification	60 MPa
Mixing rate	Up to 25 m <sup>3</sup> /hr
