Tidal Turbine in Orkney

Foundation pile grouting for the Fall of Warness (Orkney) Tidal Turbine, Scotland

Cementing a solid foundation for tidal energy in Fall of Warness, Orkney

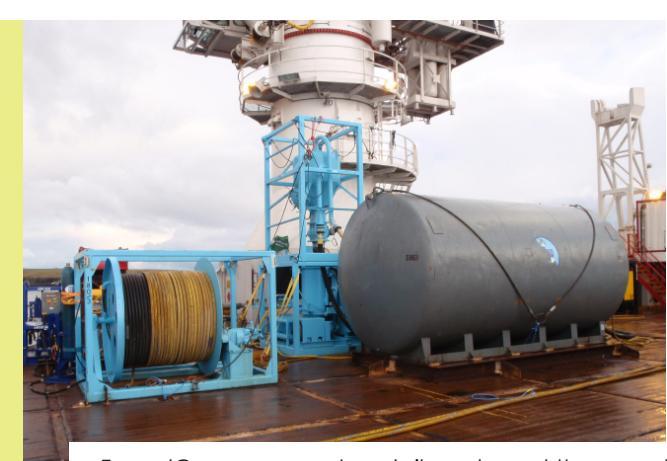
FoundOcean spread and silo onboard the vessel

Grout was stored in a bulk pressurised silo and delivered to a surge tank above the mixer. Water was delivered to the mixer from the vessel firemain pipework and measured through a water flow meter. Water was added to the mixer using a calibrated water meter set to a predetermined volume. Grout was metered into the mixer unit from the surge tank by a time controlled rotary feeder set according to required batch volume and density. The strong vortex action generated in the mixer tank immediately assimilates fresh materials as they are drawn through the mixer housing and shear mixed. The grout was then transferred to a 1,500 litre capacity holding tank from where it was drawn off by the pump and delivered to the structure via a flexible hose.

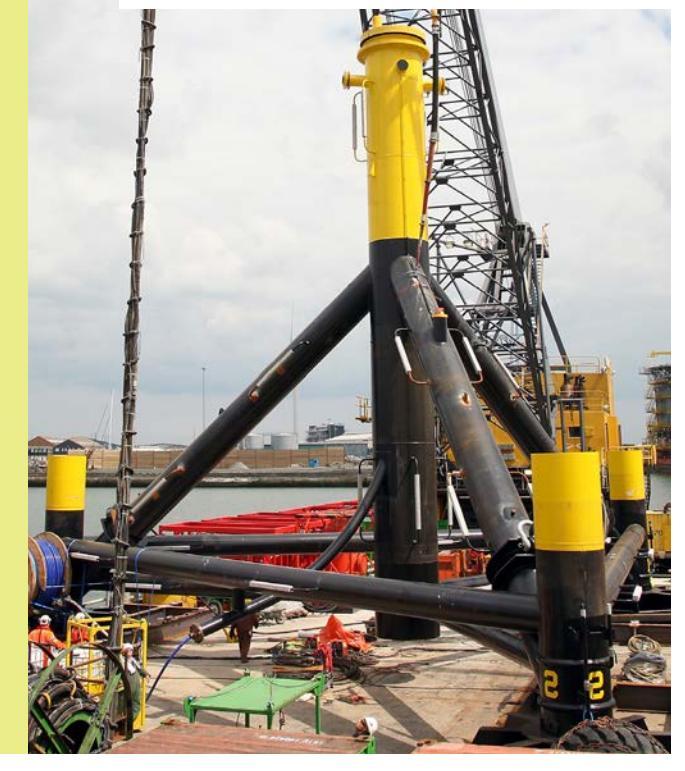
The tripod foundation for the test tidal turbine

The steel jacket has three pile sleeves in a tripod configuration. The piles are 889mm outside diameter through 1,000mm inside diameter sleeves. The piles had been drilled into nominal 1,000mm ID rock sockets. The connection between the pile, the sleeve and the rock socket was made by injecting a cement grout into the annuli. The structural integrity of the structure was therefore dependent on the placement and retention of sound grout into the pile annuli. The lower end of each sleeve was equipped with a crux type seal to retain the grout.

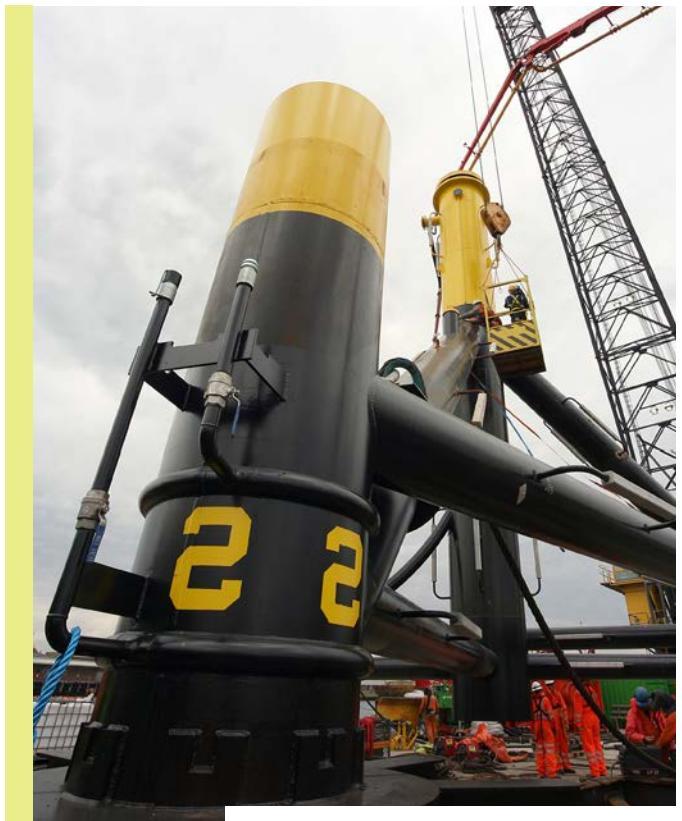
FoundOcean male Grout Connector on leg 2 of the foundation

Each sleeve had a primary and secondary grout line through which grout could be pumped into the annulus. The grout lines had been fabricated with FoundOcean 2" male grout connectors at 3m above the seabed. The grout was to be monitored visually by ROV at the top of the three sleeves.
