Hanze F2A Gravity Base Structure

Underbase grouting for the 83.5m tall, 9,000 tonne steel gravity base structure in the North Sea

Underbase grouting for the steel foundations of the largest field in the Dutch North Sea

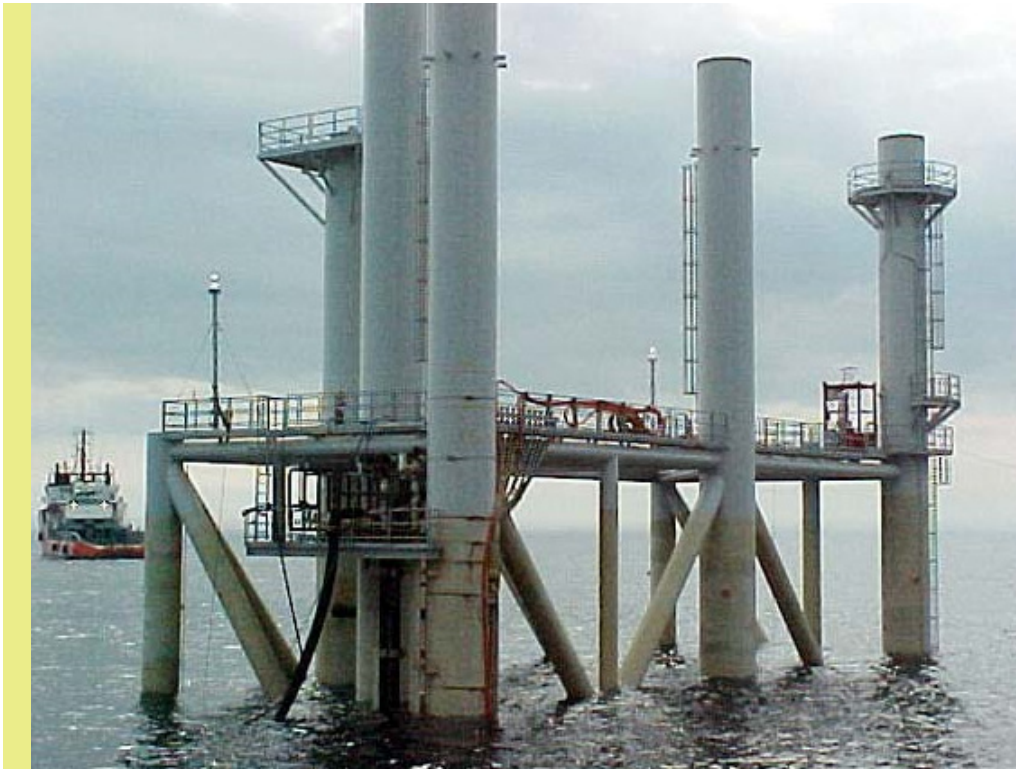
*The Hanze F2A
Gravity Base Structure
in situ*

The foundation is of steel construction and gravity base design. It contains 12 central oil storage cells, whilst the cells to the North and South ends of the structure are used for ballast water. The void formed between the underside of the base and the seabed was filled with a sodium silicate/cement grout in order to ensure an even load distribution between the structure and the seabed. The structural integrity of the platform was dependent on the correct placement and retention of good quality grout in the voids beneath the base.
