Stopping localised scour

FoundOcean developed **ScourMat** to provide a permanent solution to this problem. The ScourMat is an array of buoyant polypropylene fronds which open out to form a fan like array. They slow down the local current and cause particulate matter to settle. This builds up a new sand bank, effectively reinstating the seabed. This fibre reinforced sand bank will then resist further erosion. ScourMat does not require further maintenance.

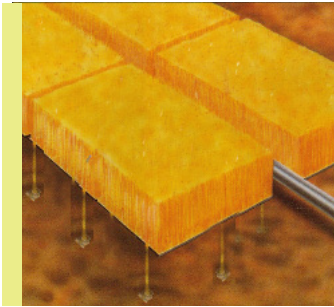
ScourMat on installation

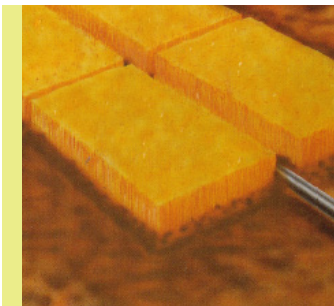
Sediment is building

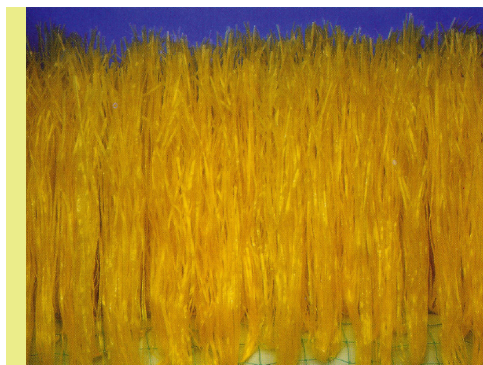
Close up of the ScourMat fronds
