# Hanze F2A Gravity Base Structure

Underbase grouting for the 83.5m tall, 9,000 tonne steel gravity base structure in the North Sea

# Underbase grouting for the steel foundations of the largest field in the Dutch North Sea

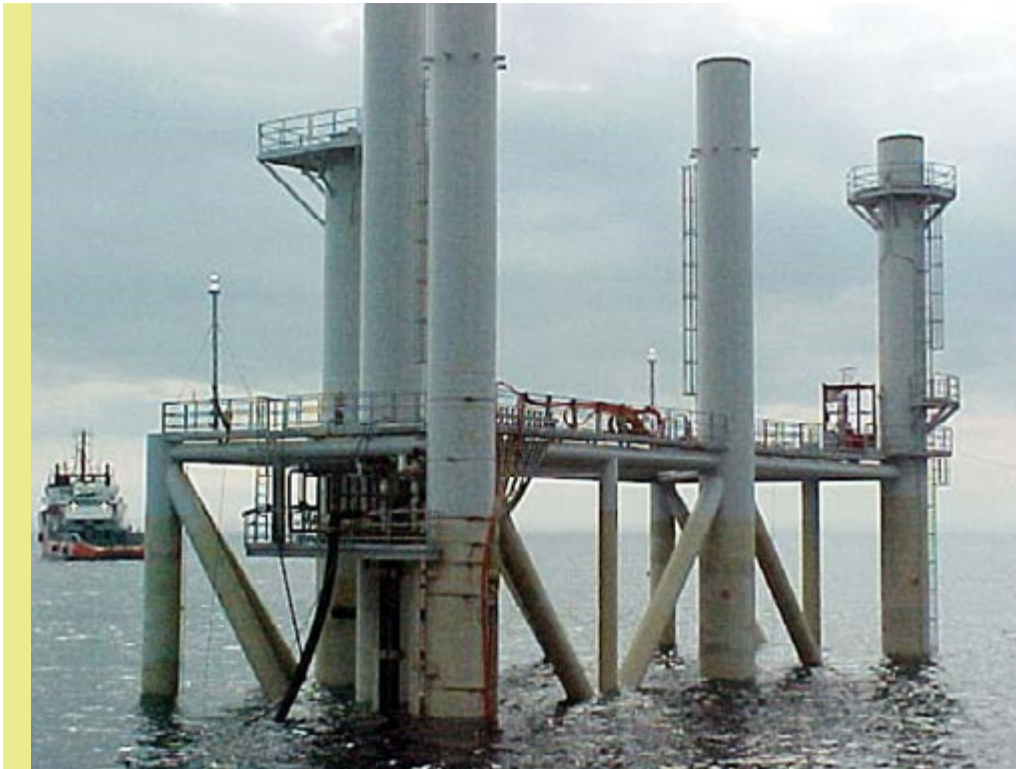
*The Hanze F2A  
Gravity Base Structure  
in situ*

The foundation is of steel construction and gravity base design. It contains 12 central oil storage cells, whilst the cells to the North and South ends of the structure are used for ballast water. The void formed between the underside of the base and the seabed was filled with a sodium silicate/cement grout in order to ensure an even load distribution between the structure and the seabed. The structural integrity of the platform was dependent on the correct placement and retention of good quality grout in the voids beneath the base.
