### Hanze F2A Gravity Base Structure

Underbase grouting for the 83.5m tall, 9,000 tonne steel gravity base structure in the North Sea

## Underbase grouting for the steel foundations of the largest field in the Dutch North Sea

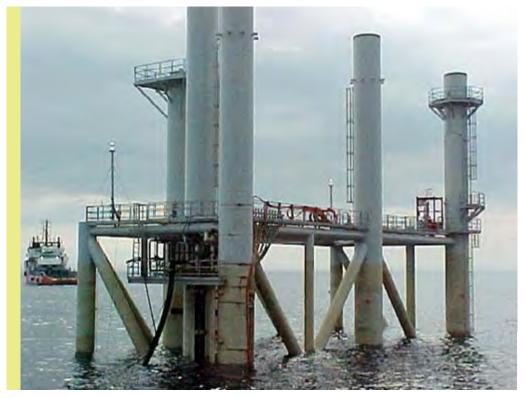
The Hanze F2A Gravity Base Structure in situ

The foundation is of steel construction and gravity base design. It contains 12 central oil storage cells, whilst the cells to the North and South ends of the structure are used for ballast water. The void formed between the underside of the base and the seabed was filled with a sodium silicate/cement grout in order to ensure an even load distribution between the structure and the seabed. The structural integrity of the platform was dependent on the correct placement and retention of good quality grout in the voids beneath the base.
