Valhall

Strengthening the Vahall Quarters Platform by injecting grout into the platform's legs

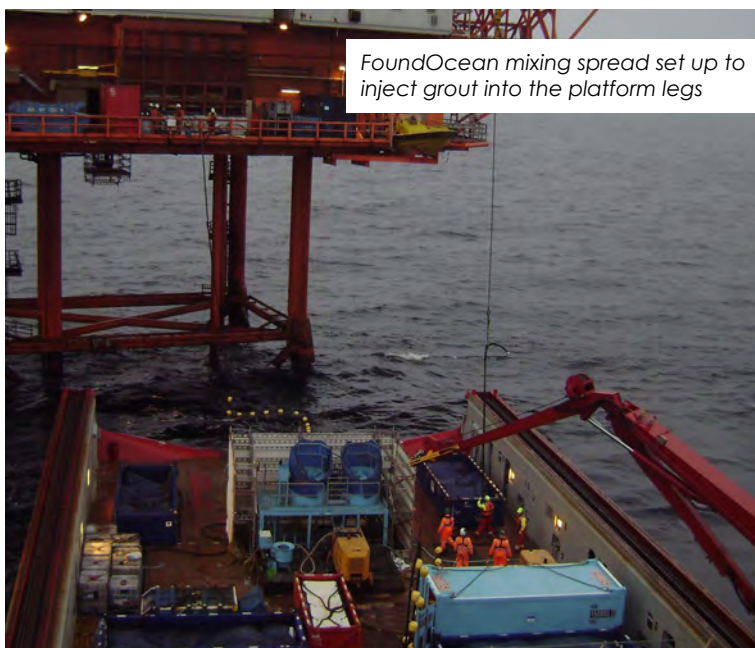
FoundOcean mixing spread set up to inject grout into the platform legs

The Valhall Quarters Platform was installed in 1979. Due to regulation changes, the jacket needed upgrading to increase its strength and resistance to freak waves. To achieve this, the four legs of the jacket were injected with grout from sea level up to the cellar deck.

The platform was prepared for grouting by the client. This involved installing the hose handling equipment, drilling the holes for the connectors, inspecting the legs and fitting the valves. FoundOcean then worked from a construction vessel to mix and pump the grout to the platform legs.

Grout was pumped from the bottom of the jacket leg to the top, a distance of 44.25m and volume of approximately 20m³. This was repeated for each leg. Sample cubes were taken to measure grout strength at 24 hours, three days and 28 days.
